# Vision Home Inspection

324 Rams Run  
Shepherdsville KY 40165-7877  
Inspector: James McFadden

## Property Inspection Report

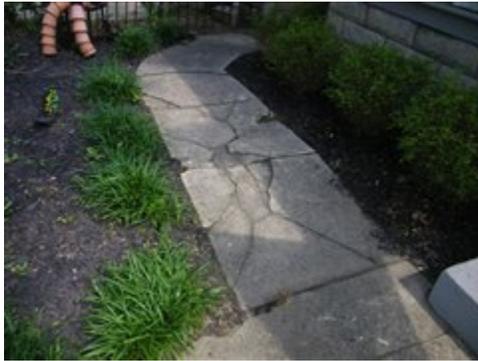
Photo 3

One or more trip hazards were found in sidewalk and/or patio sections due to cracks, settlement and/or heaving. A qualified contractor should evaluate and repair or replace sidewalk and/or patio sections as necessary to eliminate trip hazards.

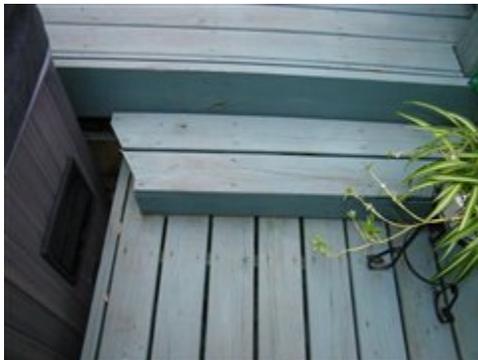
Photo 12

The step next to hot tub on the east side is loose

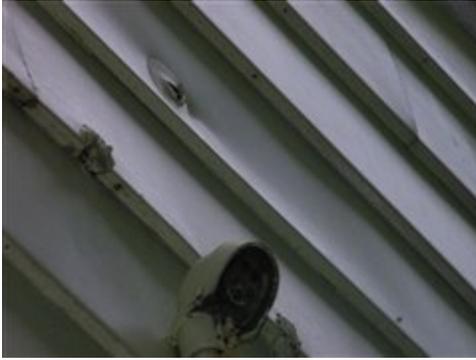
Photo 14

Exterior penetrations on the west wall. Recommend that they be sealed to avoid casual water damage and investigation.

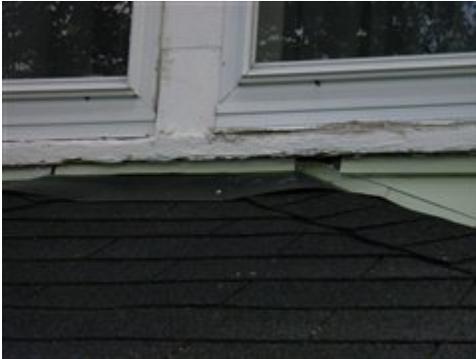
Photo 7

- 
- 5) 🛠️ Window sills show signs of moisture damage and need to be re-sealed and painted

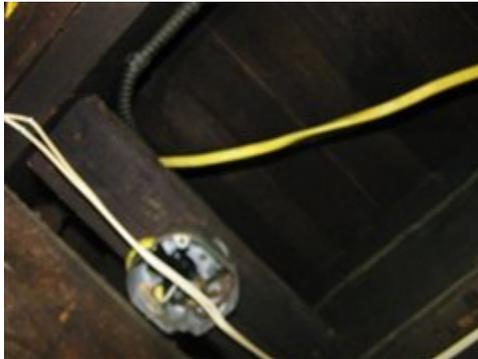
Photo 16

Cover plate(s) are missing from one or more electric boxes, such as for receptacles, switches and/or junction boxes. They are intended to contain fire and prevent electric shock from exposed wires. This is a safety hazard due to the risk of fire and shock. Cover plates should be installed where missing.  
2 in the basement

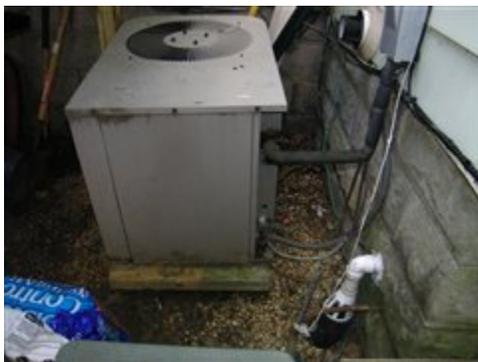
Photo 11

- 
- 10) 🛠️🔍 Air Conditioning unit is not level and the pad is not properly installed.

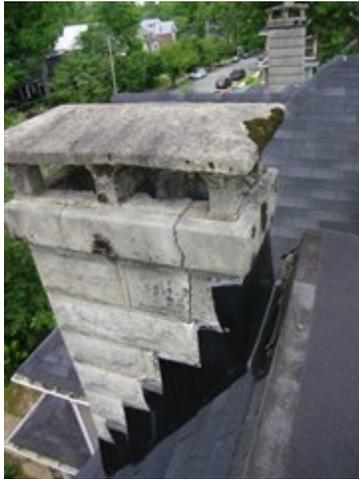
Photo 37

Masonry cracked, recommend a chimney masonry contractor be contacted to exact repairs.

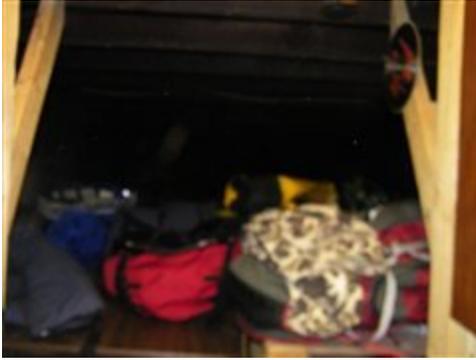
Photo 18

Some crawl space areas were inaccessible due to stored personal items, these areas are excluded from this inspection.

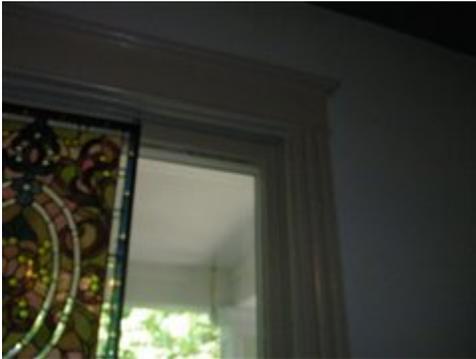
Photo 24

- 16) 🛠️👉 Main living room window is painted shut and has 2 small cracks in the upper left and right corners.

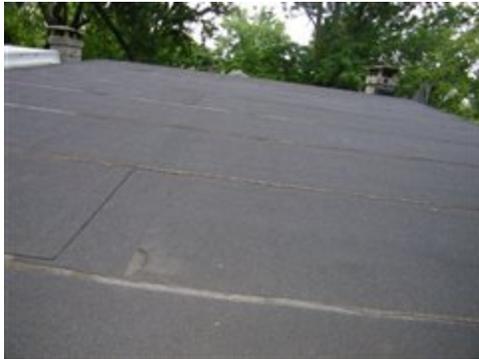
**Photo 34**

- 
- 17) 🛠️👉 Third floor roof has an exposed area approximately 1.5' by .5 to 1.5" on the front center portion. Recommend immediate repair as wood is exposed to the elements

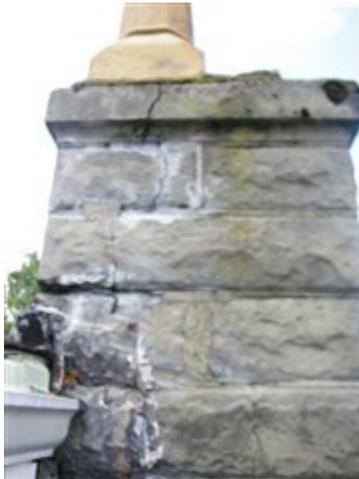
**Photo 30**

18) 🔧🔍 One or more sections of roof flashing are deteriorated and/or rusted. Leaks may occur as a result. A qualified roofing contractor should evaluate and replace flashing where necessary.

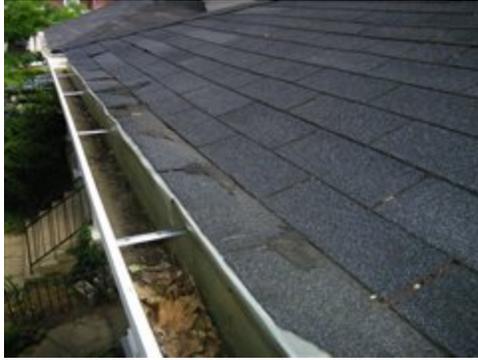
Photo 6

20) 🪄 Small Valley on front porch roof levels before emptying into gutters. May collect debris.

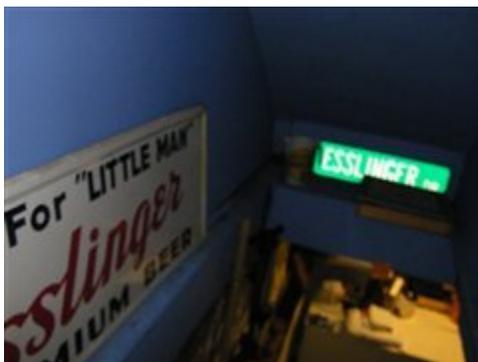
Photo 20

Evidence of prior water intrusion was found in one or more sections of the basement. For example, water stains and/or efflorescence on the foundation or floor, water stains at bases of support posts, etc. Accumulated water is a conducive condition for wood destroying insects and organisms and should not be present in the basement. The client(s) should review any disclosure statements available and ask the property owner(s) about past accumulation of water in the basement. The basement should be monitored in the future for accumulated water, especially after heavy and/or prolonged periods of rain. If water is found to accumulate, a qualified contractor who specializes in drainage issues should evaluate and repair as necessary. Typical repairs for preventing water from accumulating in the basement include:

- Repairing, installing or improving rain run-off systems (gutters, downspouts and extensions or drain lines)
- Improving perimeter grading
- Repairing, installing or improving underground footing and/or curtain drains

Ideally, water should not enter the basement, but if water must be controlled after it enters the basement, then typical repairs include installing sump pump(s) or interior perimeter drains.
